TMDL Program Five Year Progress Report

Prepared by the Virginia Department of Environmental Quality
in cooperation with the Department of Conservation and Recreation and the
Department of Mines, Minerals, and Energy

January 2005

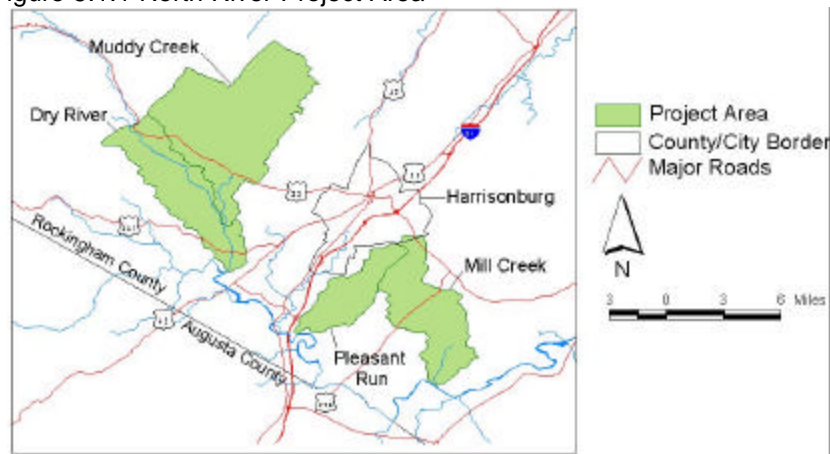
Figure 5.1.1 North River Project Area

The Lower Dry River, Muddy Creek, Pleasant Run, and Mill Creek drain into the North River located in Rockingham County, Virginia (see Figure 5.1.1). The four watersheds consist of 45,018 acres and the predominant land uses are forest (27%), agriculture (62%), and residential land (11%). The total number of sheep, horses, beef cows, dairy heifers, and dairy cows in the watersheds is 22,808. There are a total of 2,886 residences and businesses in the watersheds with septic systems.

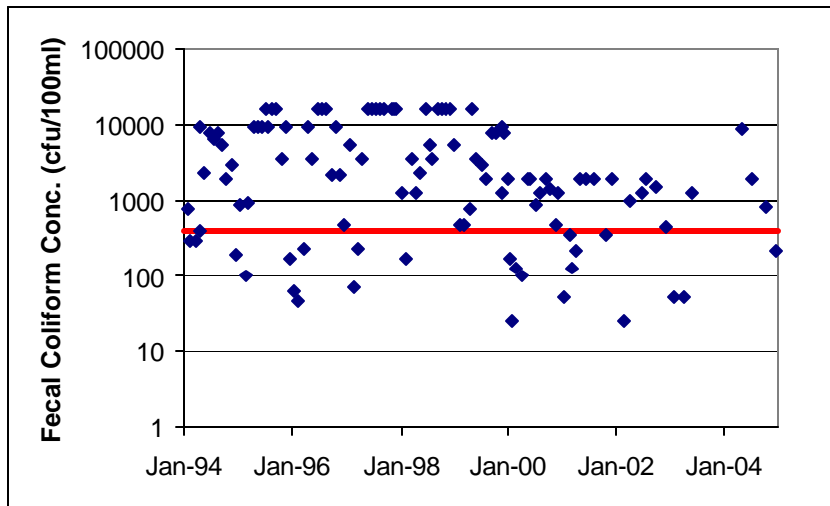
Figure 5.1.2 Muddy Creek bacteria data, monitoring station 1BMDD000.40

Figure 5.1.2 shows fecal coliform concentrations near the outlet of Muddy Creek (at station 1BMDD000.40) for the past ten years. During this time, fecal coliform concentrations have exceeded the water quality standard 77% of the time. When comparing data prior to TMDL activities in the watershed (1994-1999) to more recent data (2000-2004), however, the average of the yearly violation rate drops from 84% for 1994-1999 to 63% for 2000-2004.

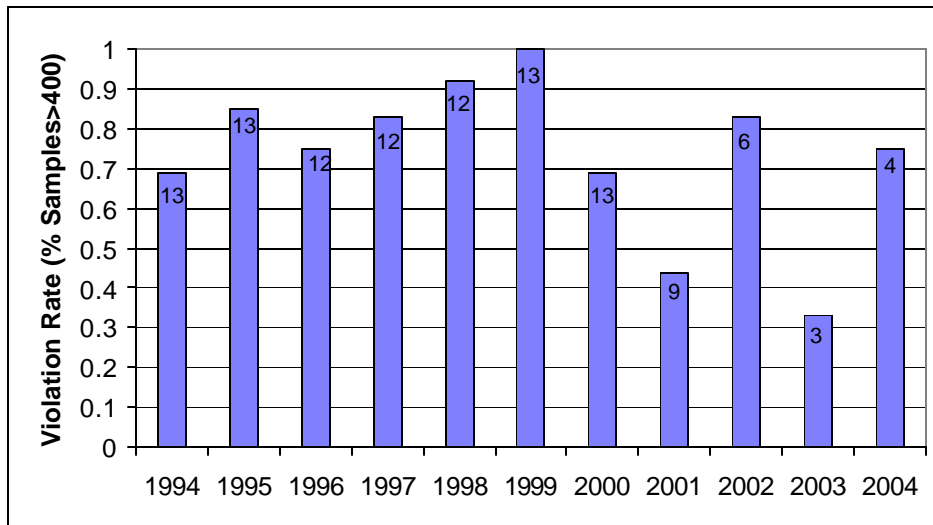
Figure 5.1.3 Muddy Creek violation rate and number of samples collected, monitoring station 1BMDD000.40

Violation rates of the fecal coliform standard are shown for each year in Figure 5.1.3. Yearly violation rates dropped following TMDL activities that began in 1999, however, these rates have rebounded in several years (2002 and 2004). Anecdotal evidence from the watershed suggests that many landowners that initially installed stream exclusion fencing removed the fencing in 2002 to allow cattle access to water during intense drought conditions. Anecdotal evidence also suggests that some exclusion fencing was destroyed by flooding from Hurricane Isabel in the fall of 2003 and flooding from multiple hurricanes in the fall of 2004. It should also be noted that yearly violation rates for the 2001-2004 period are more variable than for the earlier period because fewer samples were collected in these later years. While 12 or more samples were collected in each year from 1994-2000, only 9, 6, 3, and 4 samples were collected in 2001 through 2004, respectively.

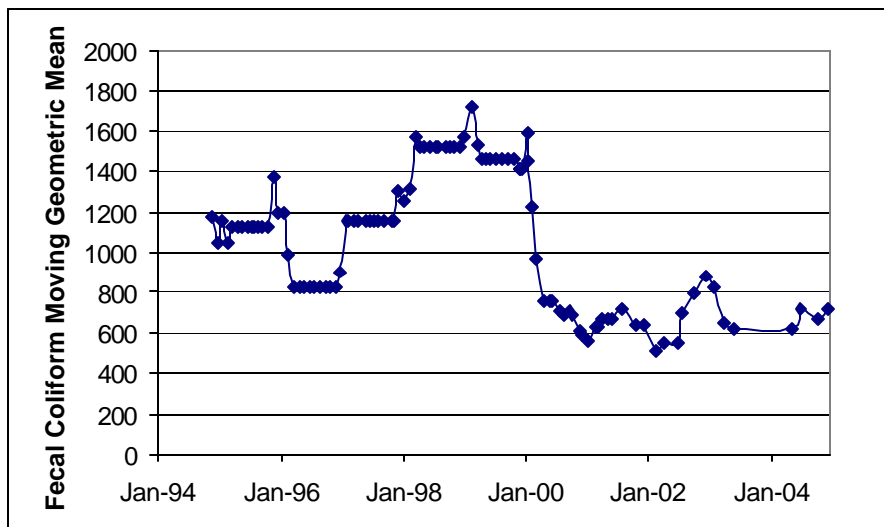
Figure 5.1.4 Muddy Creek moving geometric mean, monitoring station 1BMDD000.40

The moving geometric mean of fecal coliform concentrations also confirms that fecal coliform levels have decreased since TMDL activities began in 1999, but have been stable or slightly rebounded in more recent years (Figure 5.1.4). The rolling geometric mean was calculated for each data point as the geometric mean of that point and the 11 previous data points. The geometric mean changes through time as new data points are incorporated into the mean and older points are excluded, while always maintaining 12 data points within the averaging window for each mean. An averaging window of 12 data points was selected because it corresponded to the typical number of samples collected over the course of a year. Because means may be biased by changes in the measurement range of the analytical method over time, values were censored to remove this bias. Values were censored using the narrowest measurement range represented in the data set. Any values below 100 cfu/100ml were set to 100 cfu/100ml, and any values above 2000 cfu/100ml were set to 2000 cfu/100ml. Combined evidence from yearly fecal coliform violation rates and from the moving geometric mean of fecal coliform concentrations suggests that water quality in Muddy Creek has improved since initiation of TMDL activities in the watershed.

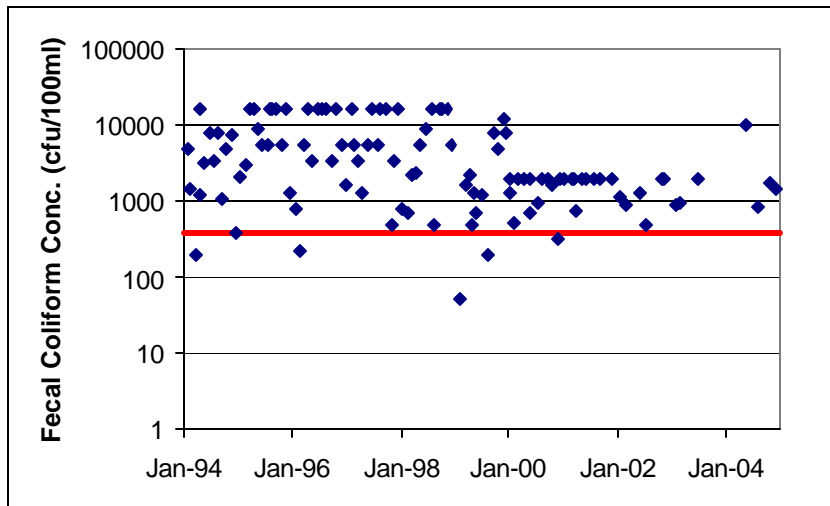
Figure 5.1.5 Pleasant Run bacteria data, monitoring station 1BPLR000.16

Figure 5.1.5 shows fecal coliform concentrations near the outlet of Pleasant Run (at station 1BPLR000.16) for the past ten years. During this time, fecal coliform concentrations have exceeded the water quality standard 94% of the time. No decreasing trend in fecal coliform concentrations is observed since TMDL activities in the watershed began in 2000. In fact, within the past four years, violations rates of the fecal coliform standard have been at 100% (Figure 5.1.6). None of the 22 fecal coliform samples collected in 2001-2004 have met the water quality standard. Moving geometric means of fecal coliform data (Figure 5.1.7), calculated as previously described, also do not show water quality improvements, with the exception of a slight drop in concentrations in 1999 and 2000 that was followed by rebounding concentrations in more recent years. In the Pleasant Run watershed, BMP implementation has not yet been of the magnitude or location to result in measurable water quality improvements at the watershed outlet.

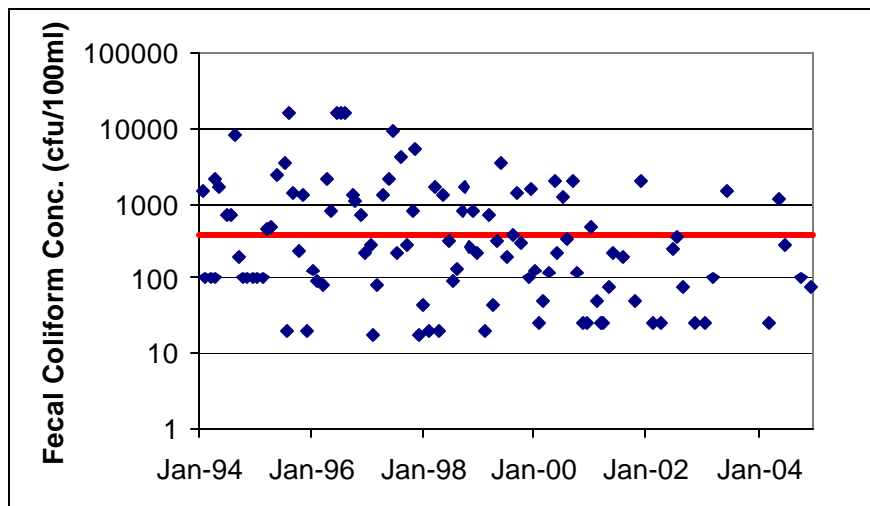
Figure 5.1.8 Lower Dry River bacteria data, monitoring station 1BDUR000.02

Figure 5.1.8 shows fecal coliform concentrations near the outlet of Dry River (at Station 1BDUR000.02) for the past ten years. During this time, fecal coliform concentrations have exceeded the water quality standard 40% of the time. When comparing data prior to TMDL activities in the watershed (1994-1999) to more recent data (2000-2004), however, the violation rate drops from an average of 49% for 1994-1999 to an average of 20% for 2000-2004. This segment is approaching the 10% violation rate threshold for 303(d) listing of bacteria impairments.

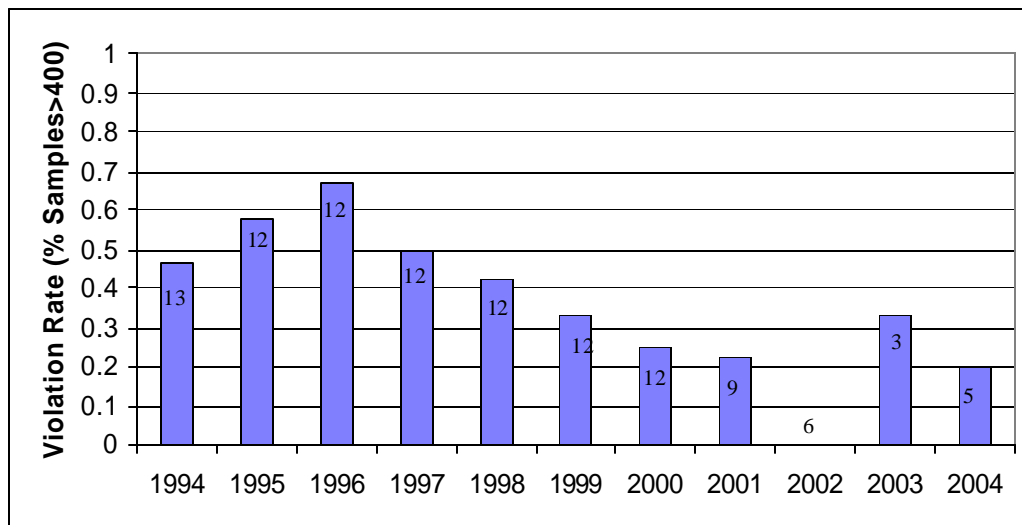
Figure 5.1.9 Lower Dry River violation rate and number of samples collected, monitoring station 1BDUR000.02

Violation rates of the fecal coliform standard are shown for each year in Figure 5.1.9. Yearly violation rates have dropped steadily beginning in 1997 to 0% in 2002. In 2002, none of the 6 samples collected exceeded the bacteria standard. Since that time, only 1 sample of 3 collected in 2003 and 1 sample of 5 collected in 2004 exceeded the bacteria standard.

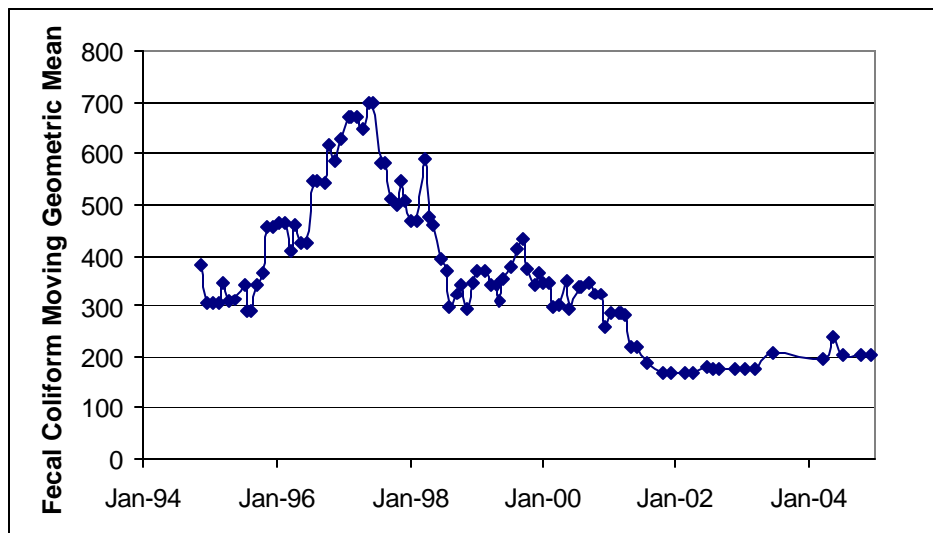
Figure 5.1.10 Dry River moving geometric mean, monitoring station 1BDUR000.02

Moving geometric means of fecal coliform data (Figure 5.1.10), calculated as previously described, also confirm the decrease in fecal coliform concentrations beginning in 1997. The rolling geometric mean indicates that fecal coliform concentrations increased dramatically around 1996 and subsequently decreased to pre-1996 levels throughout 1997 and 1998. In approximately 2000 and 2001 fecal coliform levels again decreased to the lowest levels observed in the monitoring period and have remained at approximately those levels since. It is likely that the decreases in fecal coliform levels that were observed in 2000-2001 and sustained since are due to BMP implementation in the Lower Dry River watershed and the Muddy Creek watershed. These watersheds have received the most BMP implementation of the watersheds targeted in the North River TMDL Implementation Plan. It is likely that the dramatic increase and subsequent decrease in fecal coliform levels observed around 1996 were due to other watershed or climactic factors. The year 1996 was the wettest year on record in the watershed, and contained two historic flood events (one in January and one in September). These events undoubtedly altered fecal coliform loading rates and impacted agricultural land uses in the floodplain.

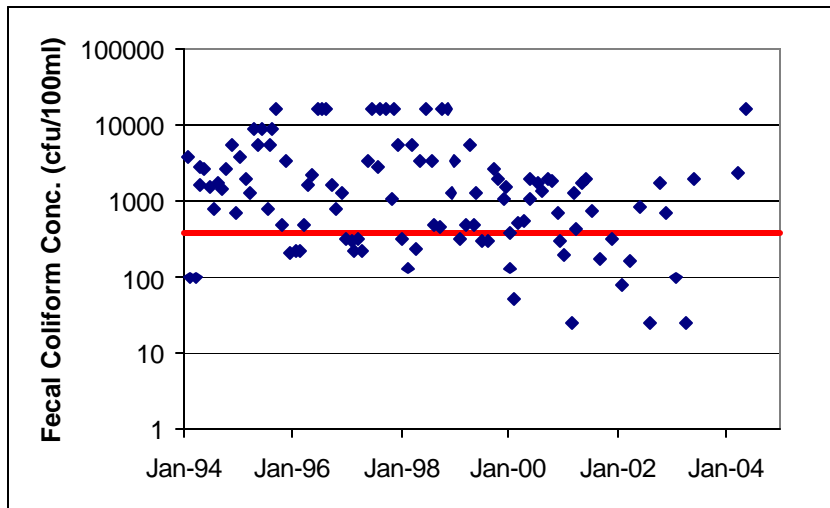
Figure 5.1.11 Mill Creek bacteria data, monitoring station 1BMIC001.00

Figure 5.1.11 shows fecal coliform concentrations near the outlet of Mill Creek (at station 1BMIC001.00) for the past ten years. During this time, fecal coliform concentrations have exceeded the water quality standard 73% of the time. When comparing data prior to TMDL activities in the watershed (1994-2000) to more recent data (2001-2004), however, the average of the yearly violation rates drops from 77% for 1994-2000 to 55% for 2001-2004.

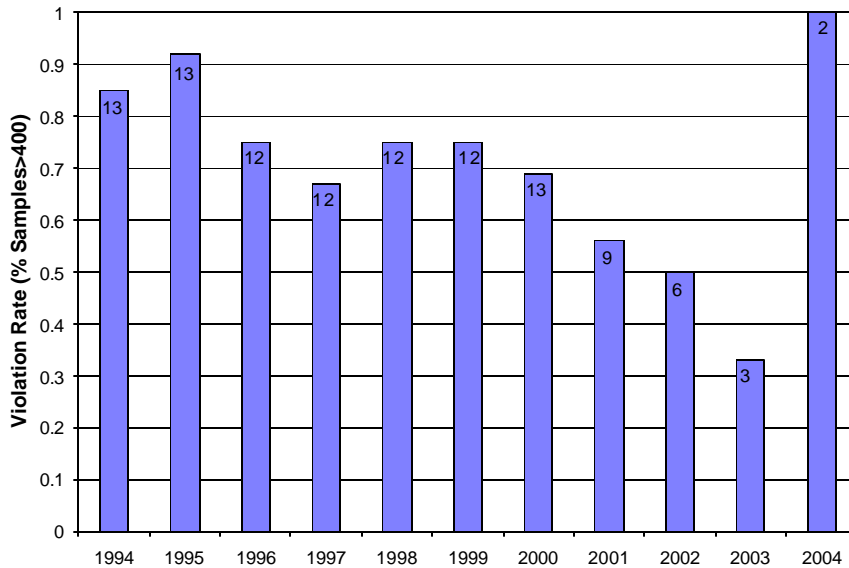
Figure 5.1.12 Mill Creek violation rate and number of samples collected, monitoring station 1BMIC001.00

Violation rates of the fecal coliform standard are shown for each year in Figure 5.1.12. Yearly violation rates have dropped steadily since 1999 with the exception of the most recent year (2004). It should be noted that only two samples were collected during 2004, and both of these samples were collected in the heart of the manure application season (3/25/04 and 5/20/04). Additional samples are needed to sufficiently evaluate yearly violation rates in this year.

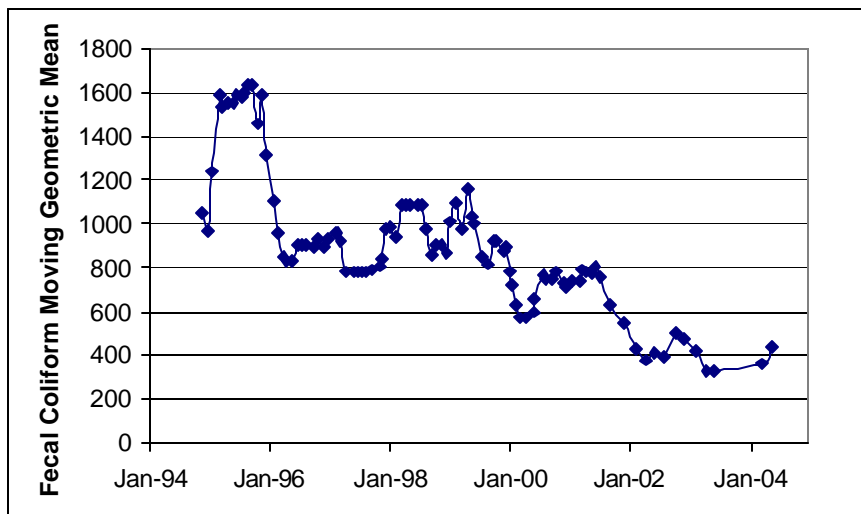
Figure 5.1.13 Mill Creek moving geometric mean, monitoring station 1BMIC001.00

Moving geometric means of fecal coliform data (Figure 5.1.13), calculated as previously described, also confirm the decrease in fecal coliform concentrations since 1999. The rolling geometric mean indicates that fecal coliform concentrations have continued to steadily decline throughout this period. In this watershed, there have been 7 grazing land protection projects for a total of 14,735 ft of stream protection. In addition, 25.4 acres of highly erodible cropland have been converted to forest and an additional 16.4 acres of cropland converted to permanent vegetation. These practices, in addition to several voluntary efforts, are likely responsible for the continued improvement in water quality in the Mill Creek watershed.

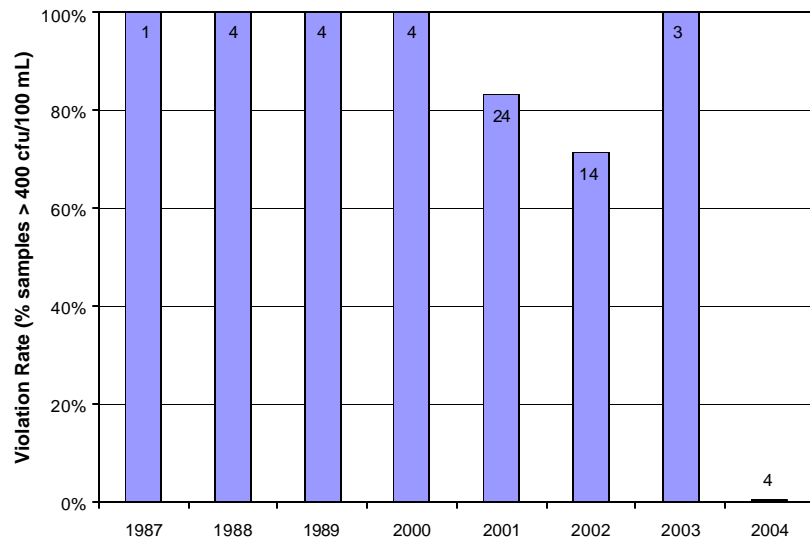
Figure 5.2.4 Cedar Creek violation rate and number of samples collected, monitoring station 6CCED000.14

Violation rates of the fecal coliform standard are shown for each year in Figure 5.2.4. Yearly violation rates began to decline in 2000 and continued to decline until 2002 (TMDL activities began in 2001). The rates have rebounded in 2003 and then declined again in 2004. While there is no clear explanation for the rebound that occurred in 2003, it is important to note that fewer samples were collected during that year so each sample was more heavily weighted in the analysis. Although this graph indicates that bacteria reduction is still needed in Cedar Creek, as the corrective actions such as livestock exclusion and septic tank pump outs gain momentum, these concentrations should continue to reduce and water quality will improve.

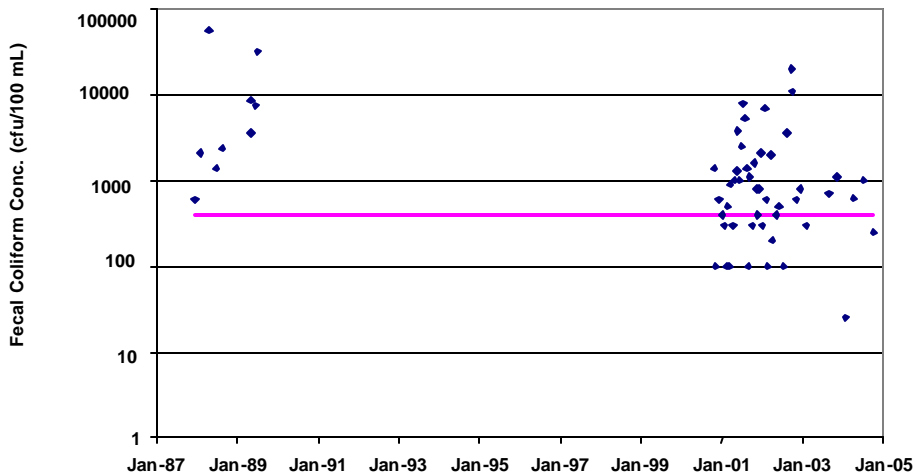
Figure 5.2.5 Hall/Byers Creek bacteria data, monitoring station 6CBYS000.23

Figure 5.2.5 shows fecal coliform concentrations near the outlet of Byers Creek (at station 6CBYS000.23) over the past 15 years. This data set has a ten to eleven year interval where there is no data. In the Hall/Byers watershed, installation of best management practices to reduce bacteria contributions to the stream actually began before the TMDL study and subsequent implementation plan development. Consequently the violation rate in 2000 was already reduced from 100 percent to less than 70 percent. Since the 2001 implementation plan, corrective actions have increased and many practices that reduce human bacteria contributions as well as practices that focus on reducing livestock bacteria contributions to the stream have been completed. It is important to note that since 2001 many of the data points are below the 400 cfu/100 mL fecal coliform criteria.

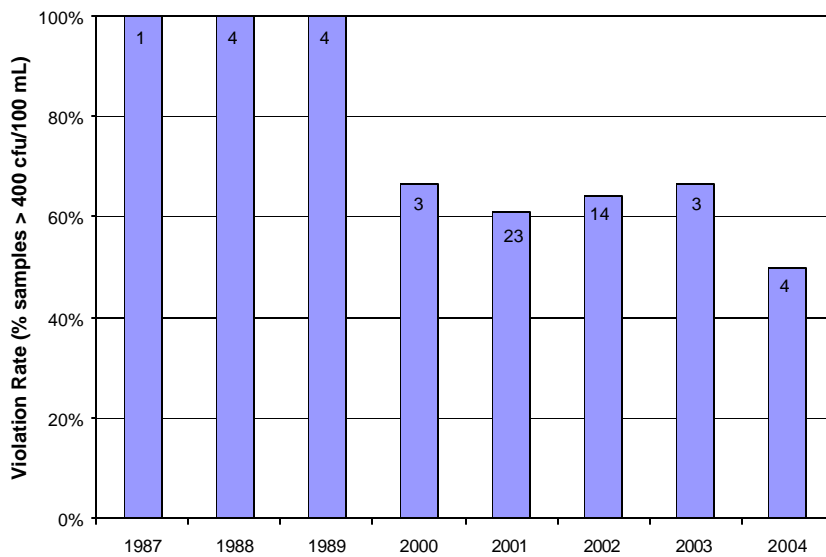
Figure 5.2.7 Hall/Byers Creek violation rates and number of samples collected, monitoring station 6CBYS000.23

Violation rates of the fecal coliform standard are shown for each year in Figure 5.2.7. Yearly violation rates have declined since monitoring resumed in 2000. Although the downward trend is not smooth, Hall Byers Creek exhibited its lowest violation rate in 2004. Anecdotal evidence from the watershed suggests that the decline in 2004 could be attributed to an increase in participation in septic pump-outs and repair during this year, or to the closure of a large dairy farm in early 2004. The implication here is not that the closure of an agricultural facility is improving water quality, but simply that there are high bacteria loadings from both residential and agricultural sources affecting water quality. The Commonwealth recommends best management practices to reduce bacteria loadings.

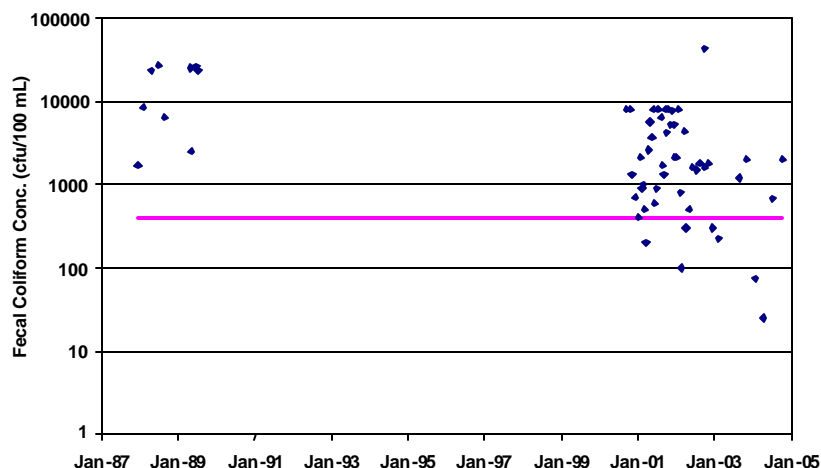
Figure 5.2.8 Hutton Creek bacteria data, monitoring station 6CHTO000.24

Figure 5.2.8 shows fecal coliform concentrations near the outlet of Hutton Creek (at station 6CHTO000.24) over the past 15 years. Monitoring data is available for 1987 through 1989 and then from 2000 to the present. Moving geometric means of fecal coliform (Figure 5.2.9), calculated as previously described, show an overall downward trend indicating a decrease in fecal coliform concentrations since 2000. This decreasing trend is further demonstrated in Figure 5.2.10 by the steadily declining violation rates beginning in 2001 through 2004.

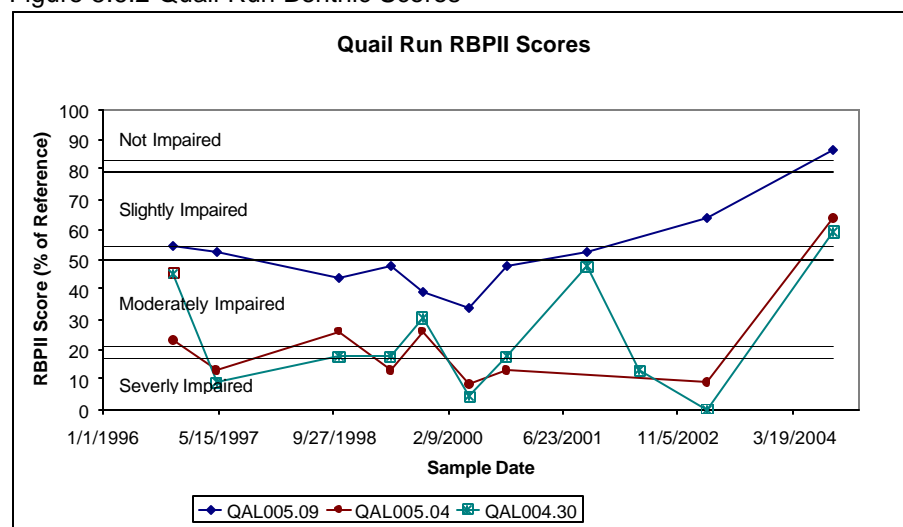
Figure 5.6.2 Quail Run Benthic Scores

The biological assessments in Quail Run were based on Rapid Bioassessment Protocol (RBP) II procedures. These follow specific guidelines in the USEPA document “Rapid Bioassessment Protocols for Use in Streams and Rivers” (Plafkin et al. 1989). Figure 5.6.2 below shows the biological assessment scores for Quail Run at three monitoring stations. Station 1BQAL005.09 is located just upstream of the Massanutten STP discharge point, station 1BQAL005.04 is located immediately downstream of the discharge, and station 1BQAL004.30 is located approximately 4000 feet below the discharge.

The most recent RBPII scores (Fall 2004) are the best since DEQ has been monitoring the stream. At station 1BQAL004.30, located below the discharge, an RBPII score could not be calculated in spring 2003 because virtually no insects could be found (reported as a zero on the graph). This past fall, the site recorded a slightly impaired condition (59.09 RBPII Score).

The graph suggests that the benthic community is improving significantly at each monitoring site.
